| BULLETIN NUMBER | DATE OF BULLETIN | DATE OF IMPLEMENTATION | S/N OF IMPLEMENTATION |
|---|---|---|---|
| T008.13 | 10/09/2013 | 10/07/2013 | 310131915 |

SUMMARY OF CHANGE:

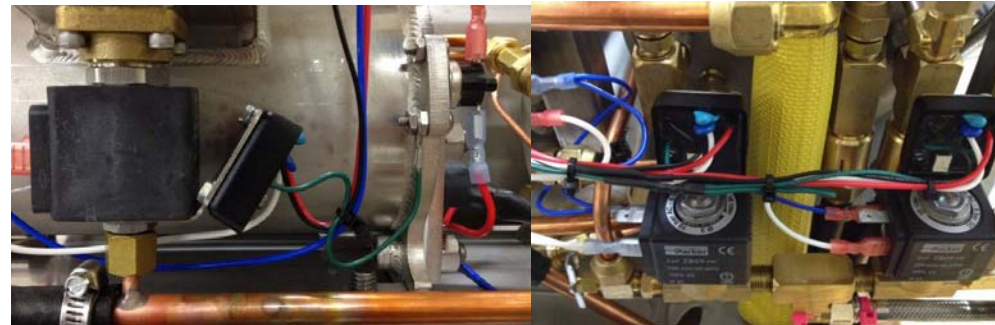
IMAGES

In a few isolated cases, the operation of the Solenoid Switches has been hindered due to insufficient grounding of the 5VDC control circuit. Under limited circumstances, the “ground” pin on the solenoid coil will not provide sufficient continuity to the frame of the machine. When this happens, the Solenoid Switch is unable to close the circuit necessary energize the solenoid coil and the valve will not open. It is for this reason that we have modified the assembly process and moved the ground wire to a more reliable grounding point. The Brew valve switches will be grounded to their corresponding brew tanks using the existing hardware for the Thermal Limit Switches. The Steam fill and Hot/Cold Water valves will be joined together and mount to the Thermal Limit switch hardware of the Right brew group.
